Hanuabada bypass open

AFTER a month and a half, the bypass road leading from the Kouraway Road roundabout to Ranuguri has opened up a lane to allow for vehicles to drive through.

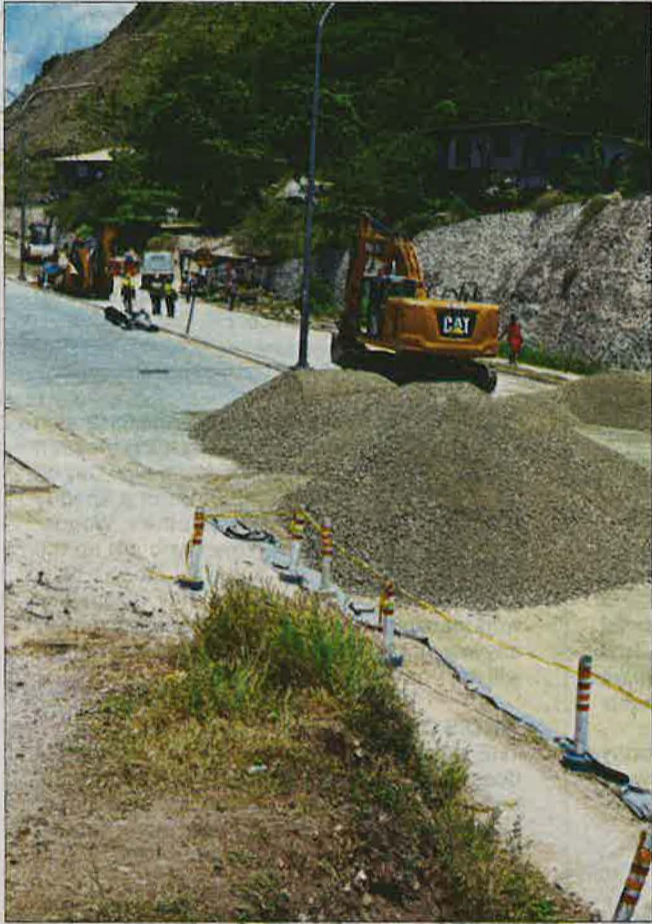
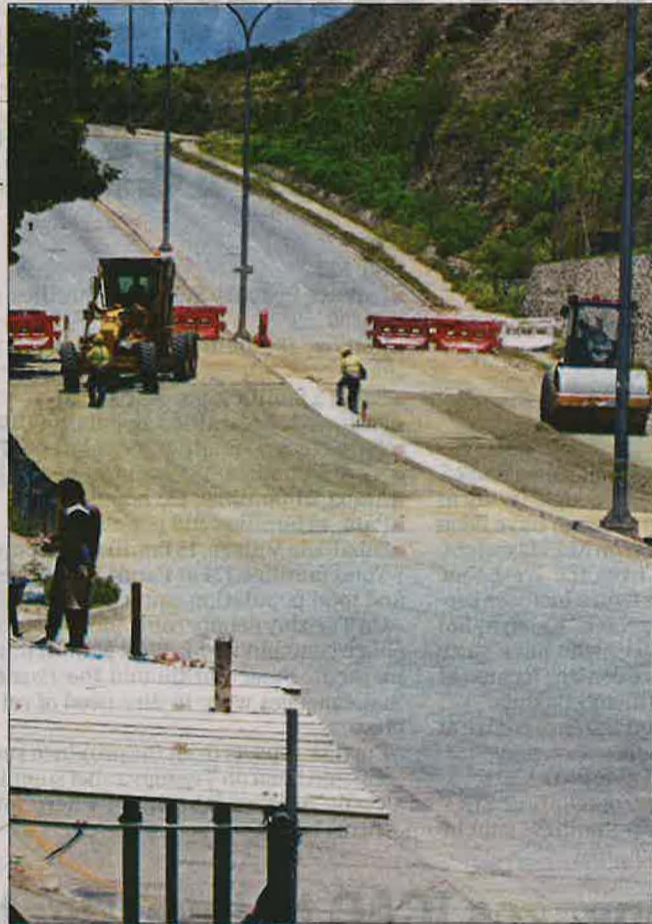
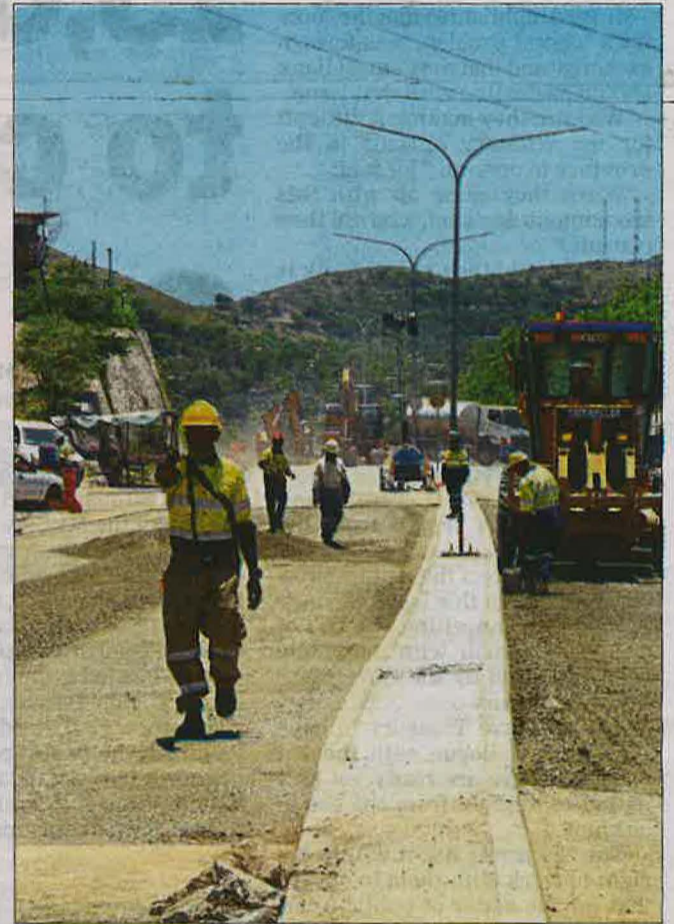
BEFORE

The road which had cracked around September and is used by heavy loaded vehicles, dropped causing a bump that slowed vehicles.

The tremor caused structural damage to the road, primarily due to the inadequate compaction of its bottom layers, resulting in a noticeable depression on its surface.

Upon receiving the Chief's communication, the City Manager promptly dispatched an engineering team to assess the situation and conduct a soil test to ensure the safety of commuters; gravel was laid as a temporary solution. While NCDC organised to engage

A road construction company was awarded the contract for 1 month to repair the road. Within two weeks, they successfully completed one lane, and they are currently focused on completing the second lane. The dimensions of the road repair cover a length of 60 metres, a width of six metres, and a depth of three metres, ensuring the restoration of a safe and strong roadway.
